**NASA
Technical
Paper
2190**

Crash Tests of Three Identical Low-Wing Single-Engine Airplanes

**Claude B. Castle
and Emilio Alfaro-Bou**

**Claude B. Castle
and Emilio Alfaro-Bou**
*Langley Research Center
Hampton, Virginia*

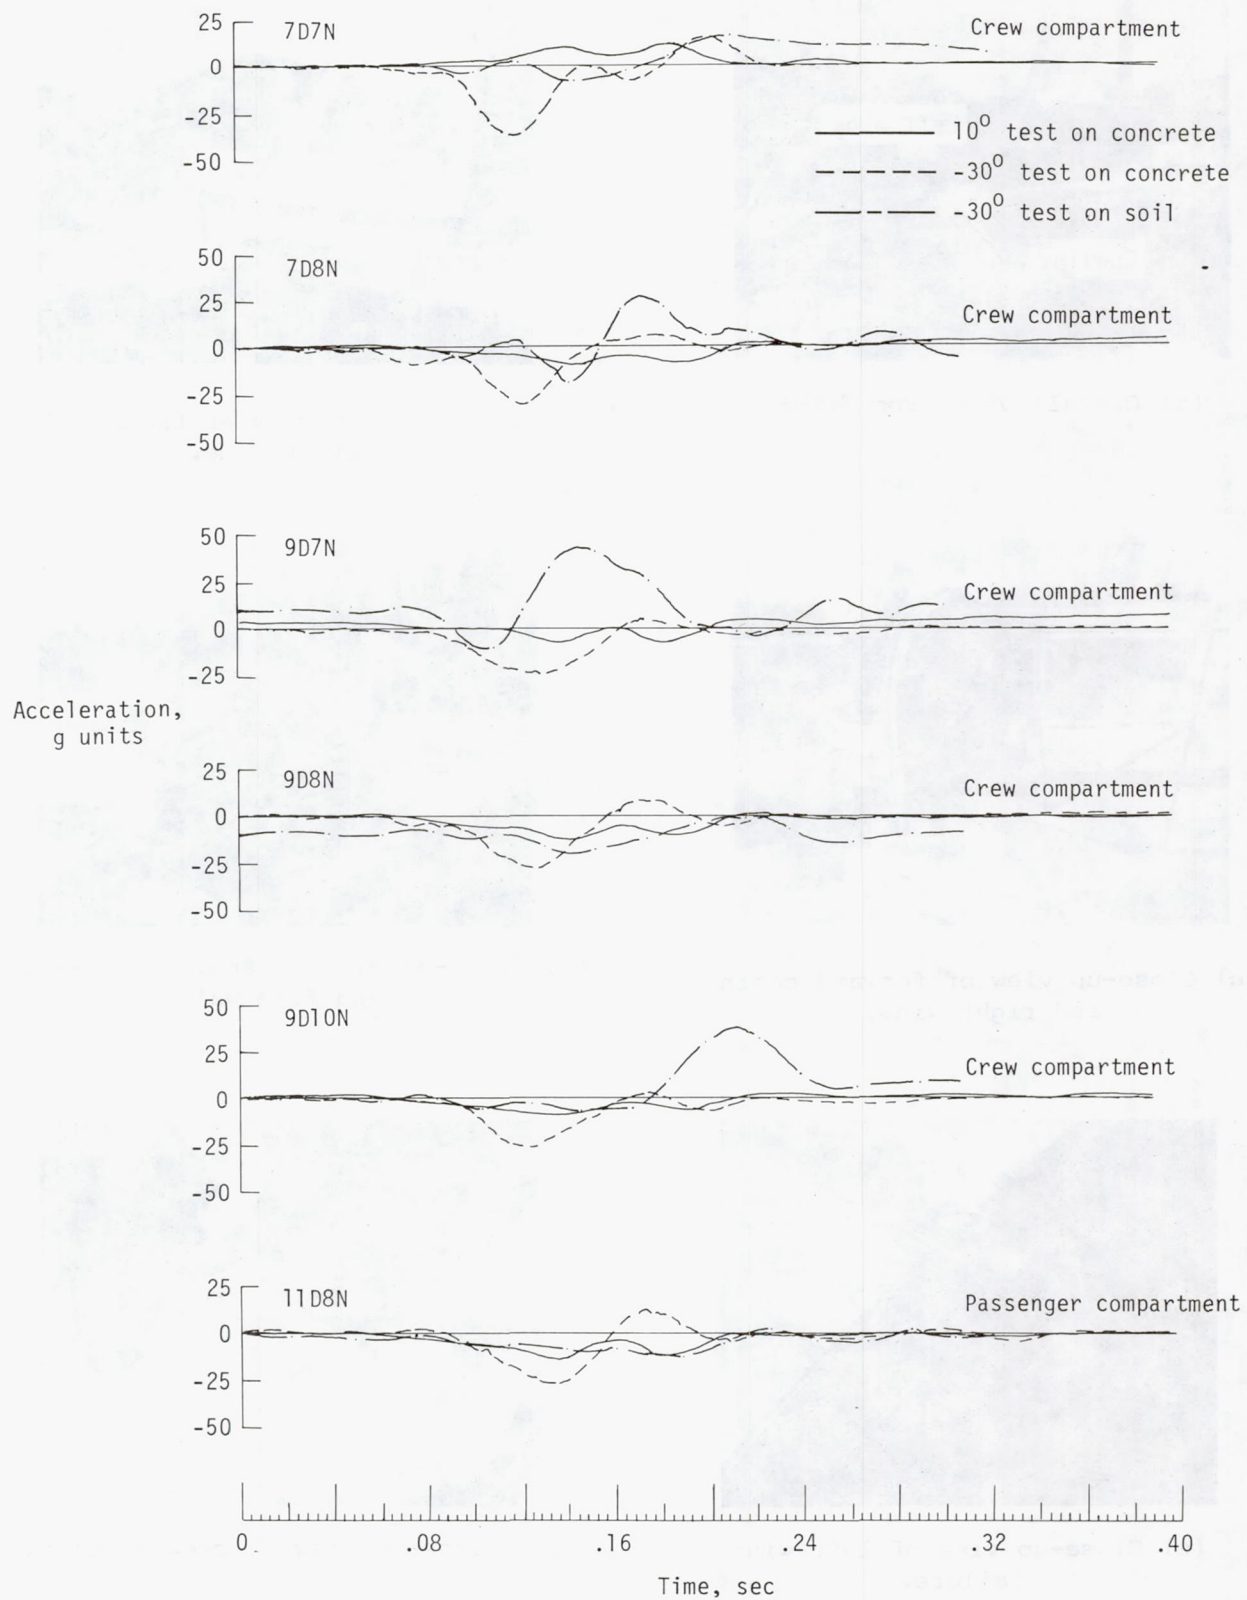
Figure 15.- Normal accelerations on cabin floor in crew and passenger compartments.

Cabin floor.- Normal accelerations on the cabin floor in the crew and passenger compartments for the three tests are presented in figure 15. The crew compartment is located forward of the main spar, and the passenger compartment is located immediately aft of the main spar. Floor accelerometers were placed adjacent to each leg of the pilot's seat, to the right rear leg of the copilot's seat, and to the front inboard leg of the first-passenger's seat. To obtain an overall acceleration value for the cabin floor in each test, three peak accelerations on the inboard floor beam located under the seats of the pilot and first passenger were averaged and compared. The beam was chosen for its location (toward the center of the fuselage) and for its rigidity (accelerations less susceptible to local deformations). In the discussion that follows, it should be noted that only the first significant acceleration peaks are being compared.

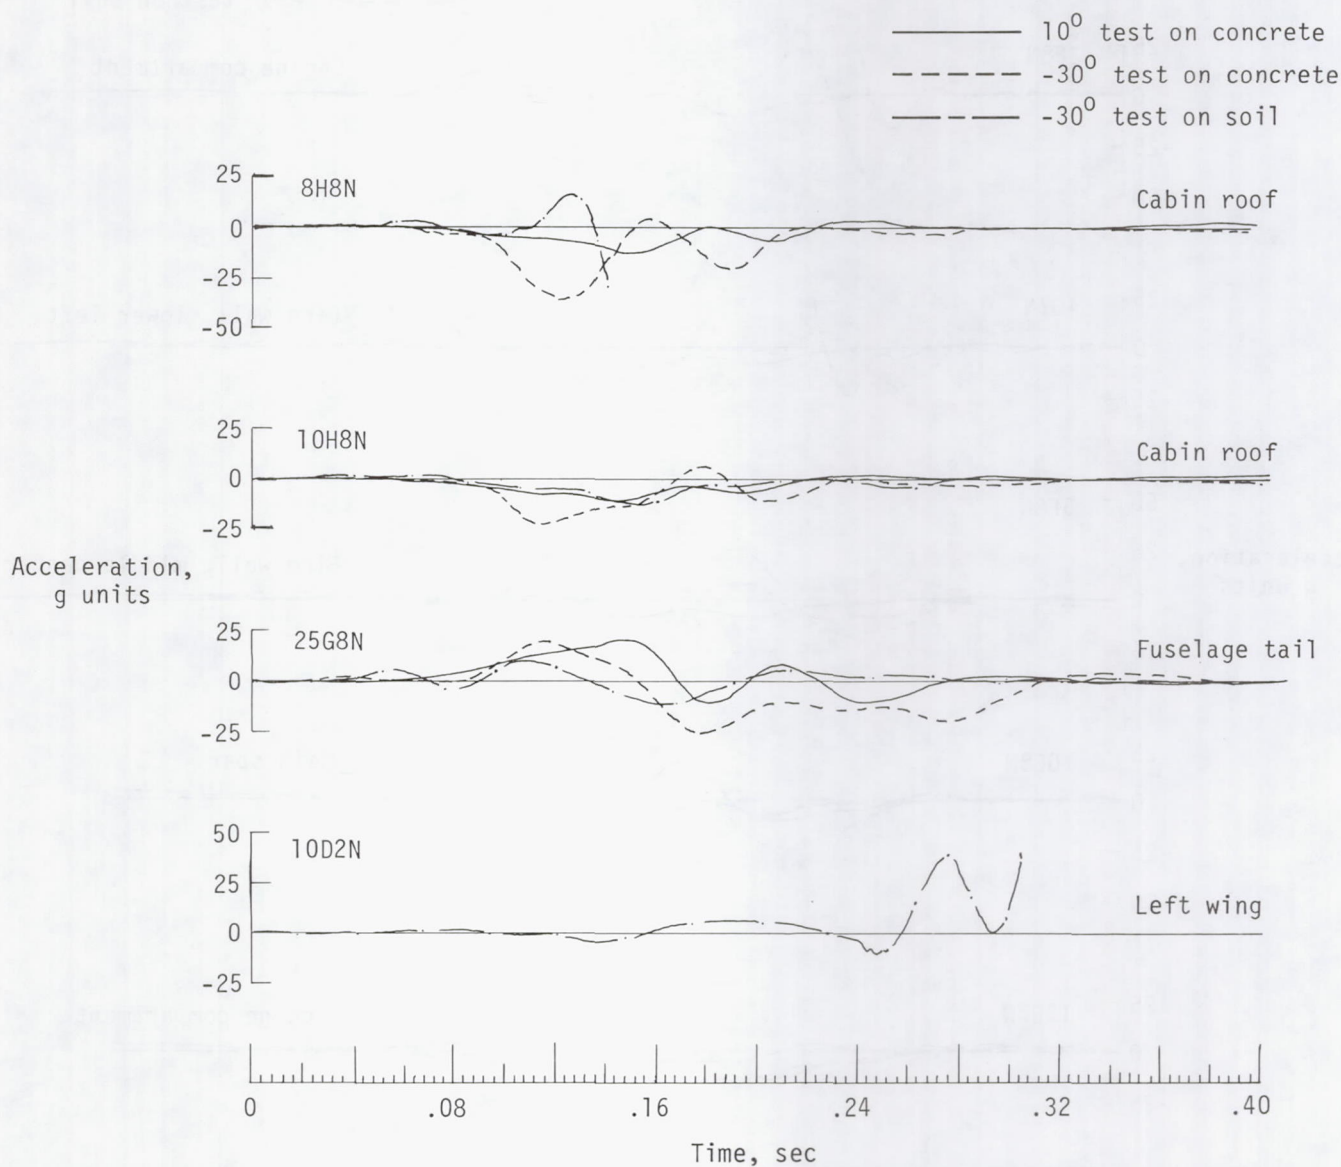
Figure 16.- Normal peak accelerations on cabin roof, fuselage tail, and left wing.

Cabin roof, fuselage tail, and left wing.- Normal peak accelerations on the cabin roof, fuselage tail, and left wing are presented in figure 16. Peak accelerations on the roof in the crew compartment averaged -12g for the 10° test on concrete, -31g for the -30° test on concrete, and -10g for the -30° test on soil. On the tail, the peak accelerations, apparently because of the structural flexibility, varied from 20g to -12g for the 10° test on concrete, 19g to -27g for the -30° test on concrete, and 10g to -11g for the -30° test on soil. On the wing, a -5g peak acceleration occurred at impact for the -30° test on soil, with a maximum acceleration of 39g as the wings were torn from the fuselage. Wing accelerations for the other two tests were not recorded.

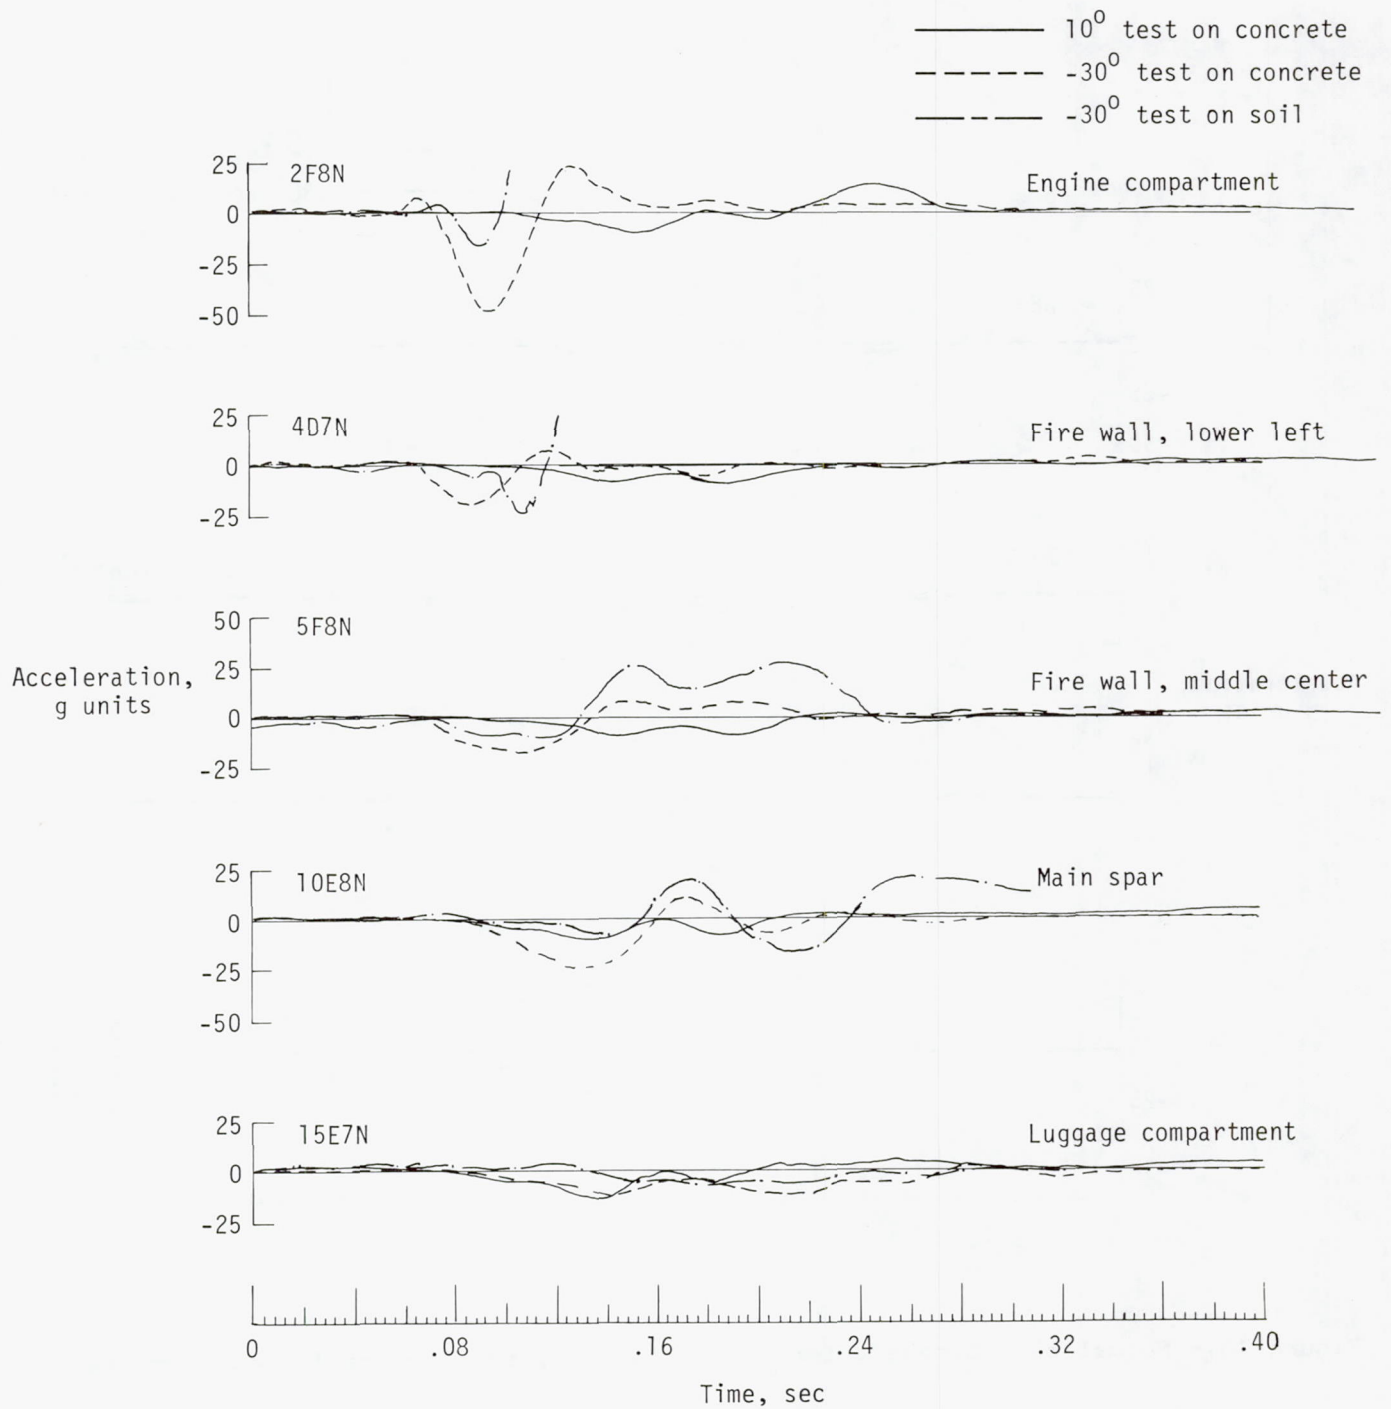
Figure 17.- Normal accelerations in engine compartment and fire wall, main spar, and luggage compartment.

Engine compartment, main spar, and luggage compartment. Normal accelerations in the engine compartment, main spar, and luggage compartment are presented in figure 17. Normal accelerometers mounted on the engine recorded -12g in the 10° test on concrete, -52g in the -30° test on concrete, and -18g for the -30° test on soil. On the fire wall, the average peak accelerations were -12g, -20g, and -25g, respectively; on the main spar, they were -12g, -25g, and -9g, respectively; and in the luggage compartment, they were -11g, -13g, and -7g, respectively. In general, the normal peak accelerations at these locations were highest for the -30° test on concrete, with the exception of an accelerometer on the middle of the fire wall that

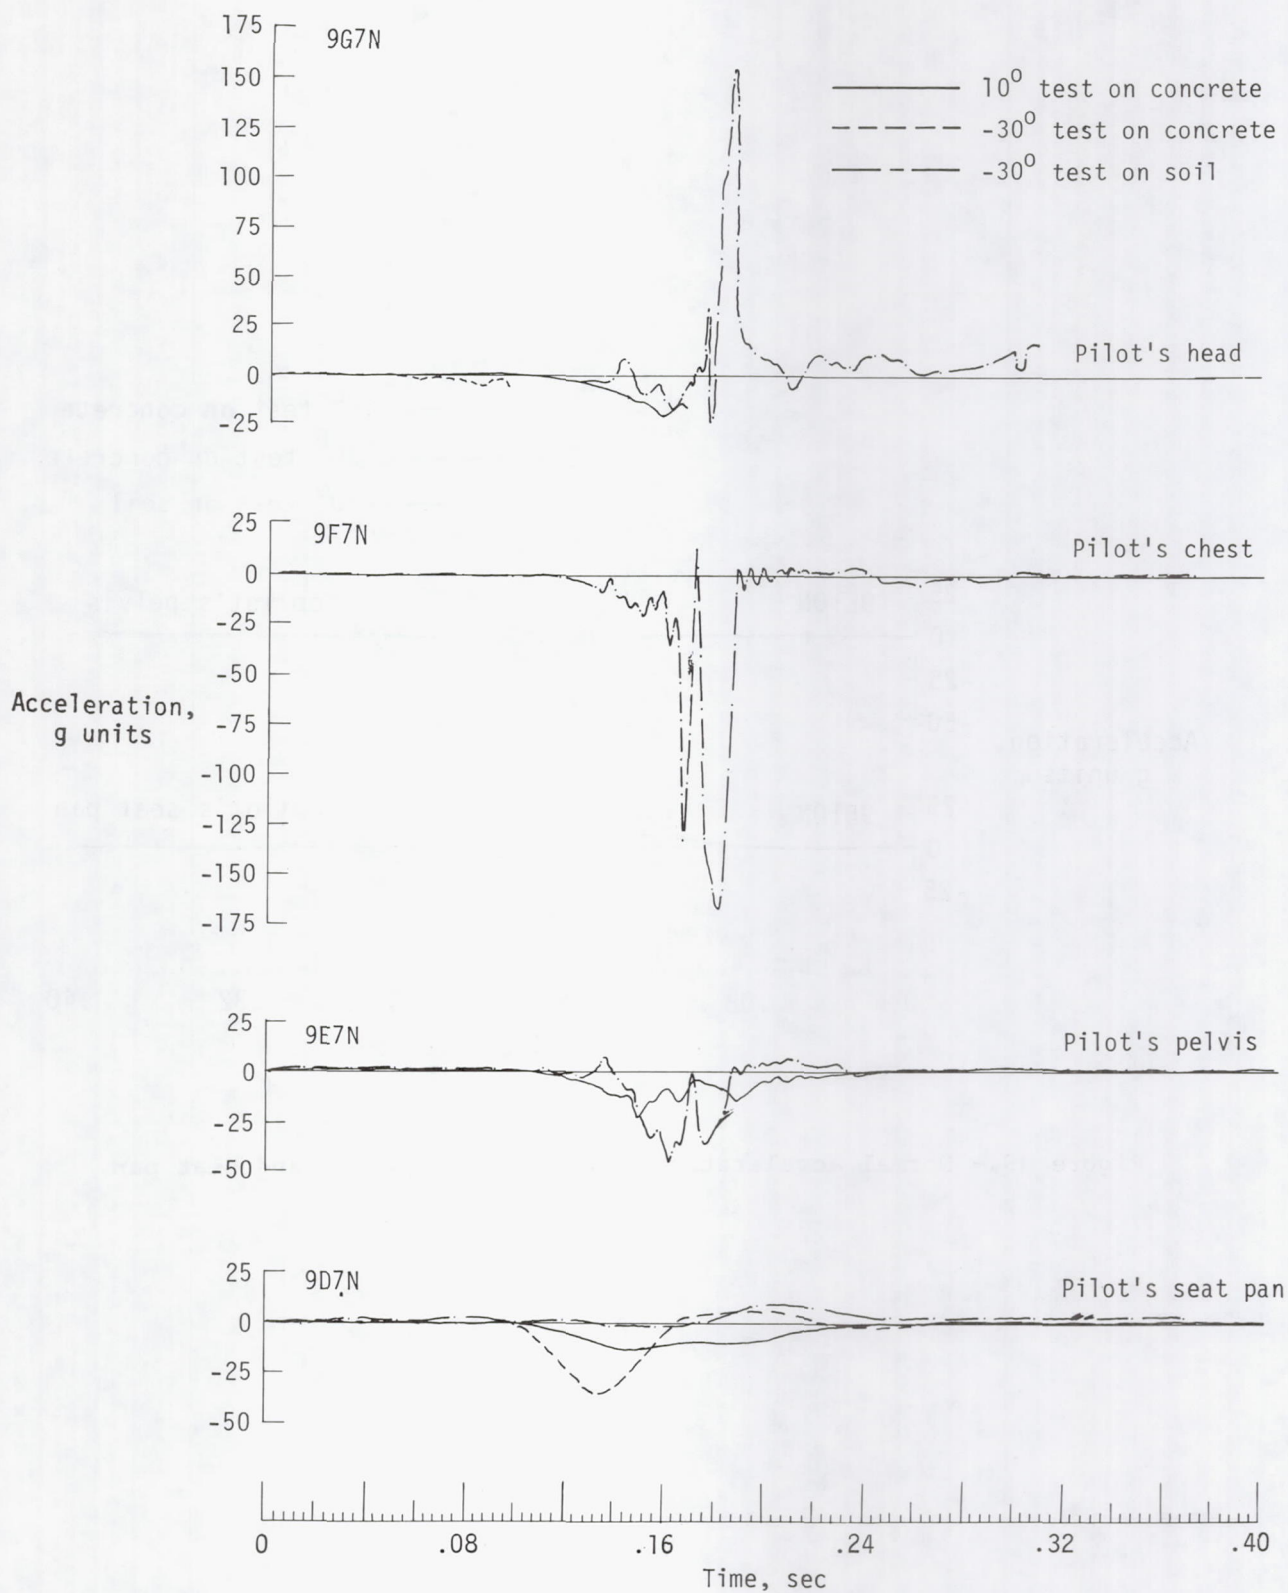
Figure 18.- Normal accelerations in pilot's body and seat pan.

Pilot's body and seat pan.- Normal accelerations in the pilot's body and seat pan are presented in figure 18. In the 10° test on concrete, peak accelerations of -20g and -22g were recorded in the pilot's head and pelvis, respectively. A peak acceleration of -14g was recorded at the seat pan. No acceleration was recorded on the pilot's chest for this test. In the -30° test on concrete, a peak acceleration of -37g was recorded at the pilot's seat pan. No accelerations were recorded at the head, chest, or pelvis. In the -30° test on soil, peak accelerations of 155g, -168g, -46g, and -8g were recorded in the pilot's head, chest, pelvis, and seat pan, respectively. From a high-speed motion-picture analysis, it was observed that during the impact of the airplane on the soil, the dummy's head impacted the instrument panel on the right side of the control stick. The high positive acceleration value (155g) recorded in the head and the negative value (-168g) in the chest are a consequence of this impact. The normal acceleration of -8g in the seat pan occurred primarily because the soil impact was essentially a high longitudinal loading in which the dummies' moving forward unloaded the seat-pan area.

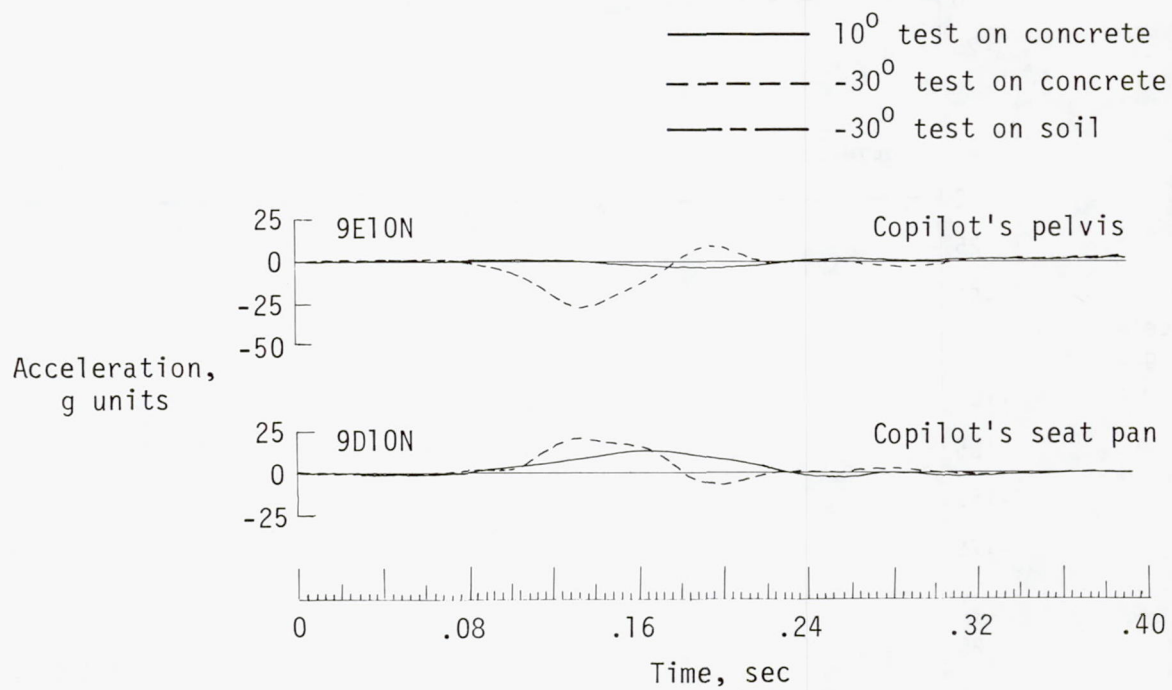
Figure 19.- Normal accelerations in copilot's pelvis and seat pan.

Copilot's pelvis and seat pan.- Normal accelerations in the copilot's pelvis and seat pan are presented in figure 19. In the 10° test on concrete, the peak acceleration recorded in the dummy's pelvis was -4g and in the seat pan was -14g. In the -30° test on concrete, the peak acceleration recorded in the pelvis was -29g and in the seat pan was -20g. Acceleration data at these locations were lost for the -30° test on soil.

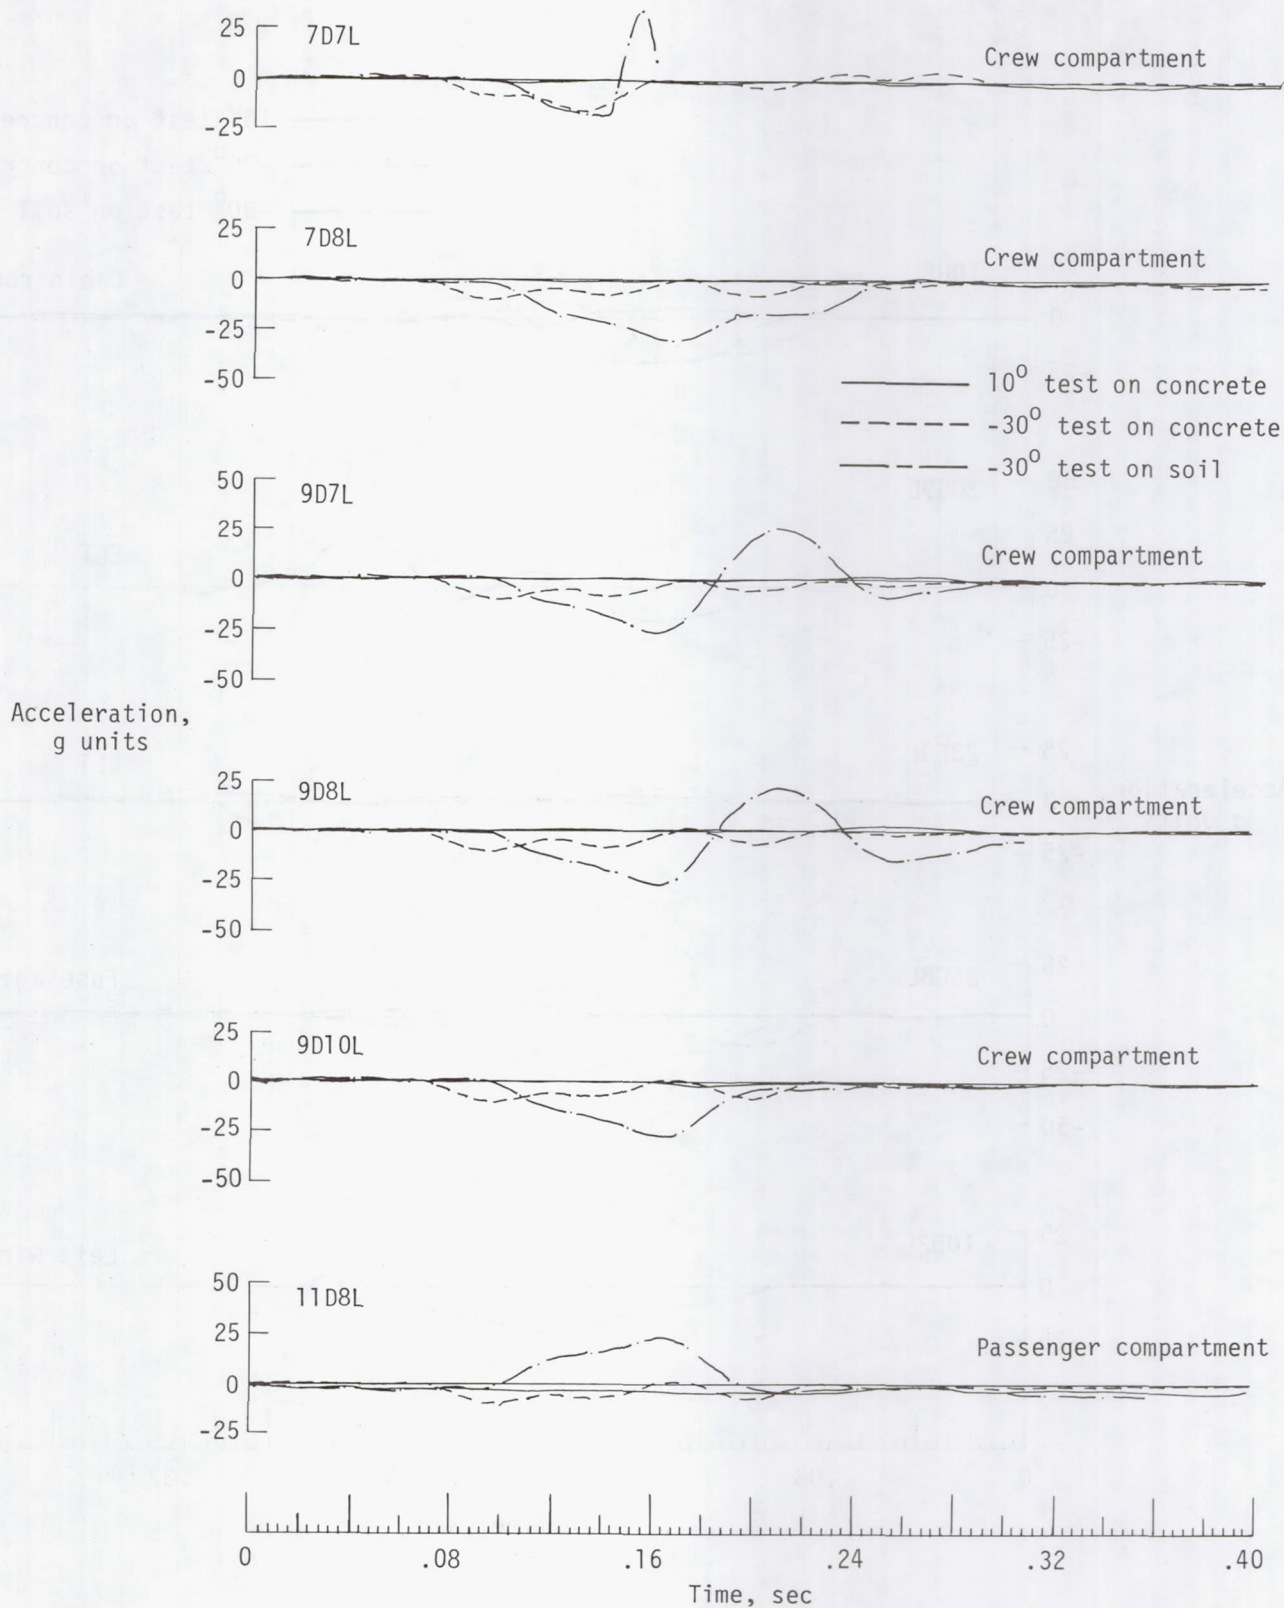
Figure 20.- Longitudinal accelerations on cabin floor in crew and passenger compartments.

Cabin floor.- Longitudinal accelerations on the cabin floor in the crew and passenger compartments in the vicinity of the pilot, copilot, and first-passenger locations for the three tests are presented in figure 20. Peak accelerations taken at three locations along the inboard floor beam under the pilot and first passenger were averaged for each test to obtain a representative cabin-floor peak acceleration. Average floor peak acceleration were -2g for the 10° test on concrete, -11g for the -30° test on concrete, and -26g for the -30° test on soil. Local accelerations for each test were distributed rather evenly both in the crew compartment and across the floor beam. Longitudinal accelerations are a function of the velocity change during initial impact. The tests with longer slide-out distances produced lower longitudinal accelerations because a lower longitudinal velocity change occurred at initial impact.

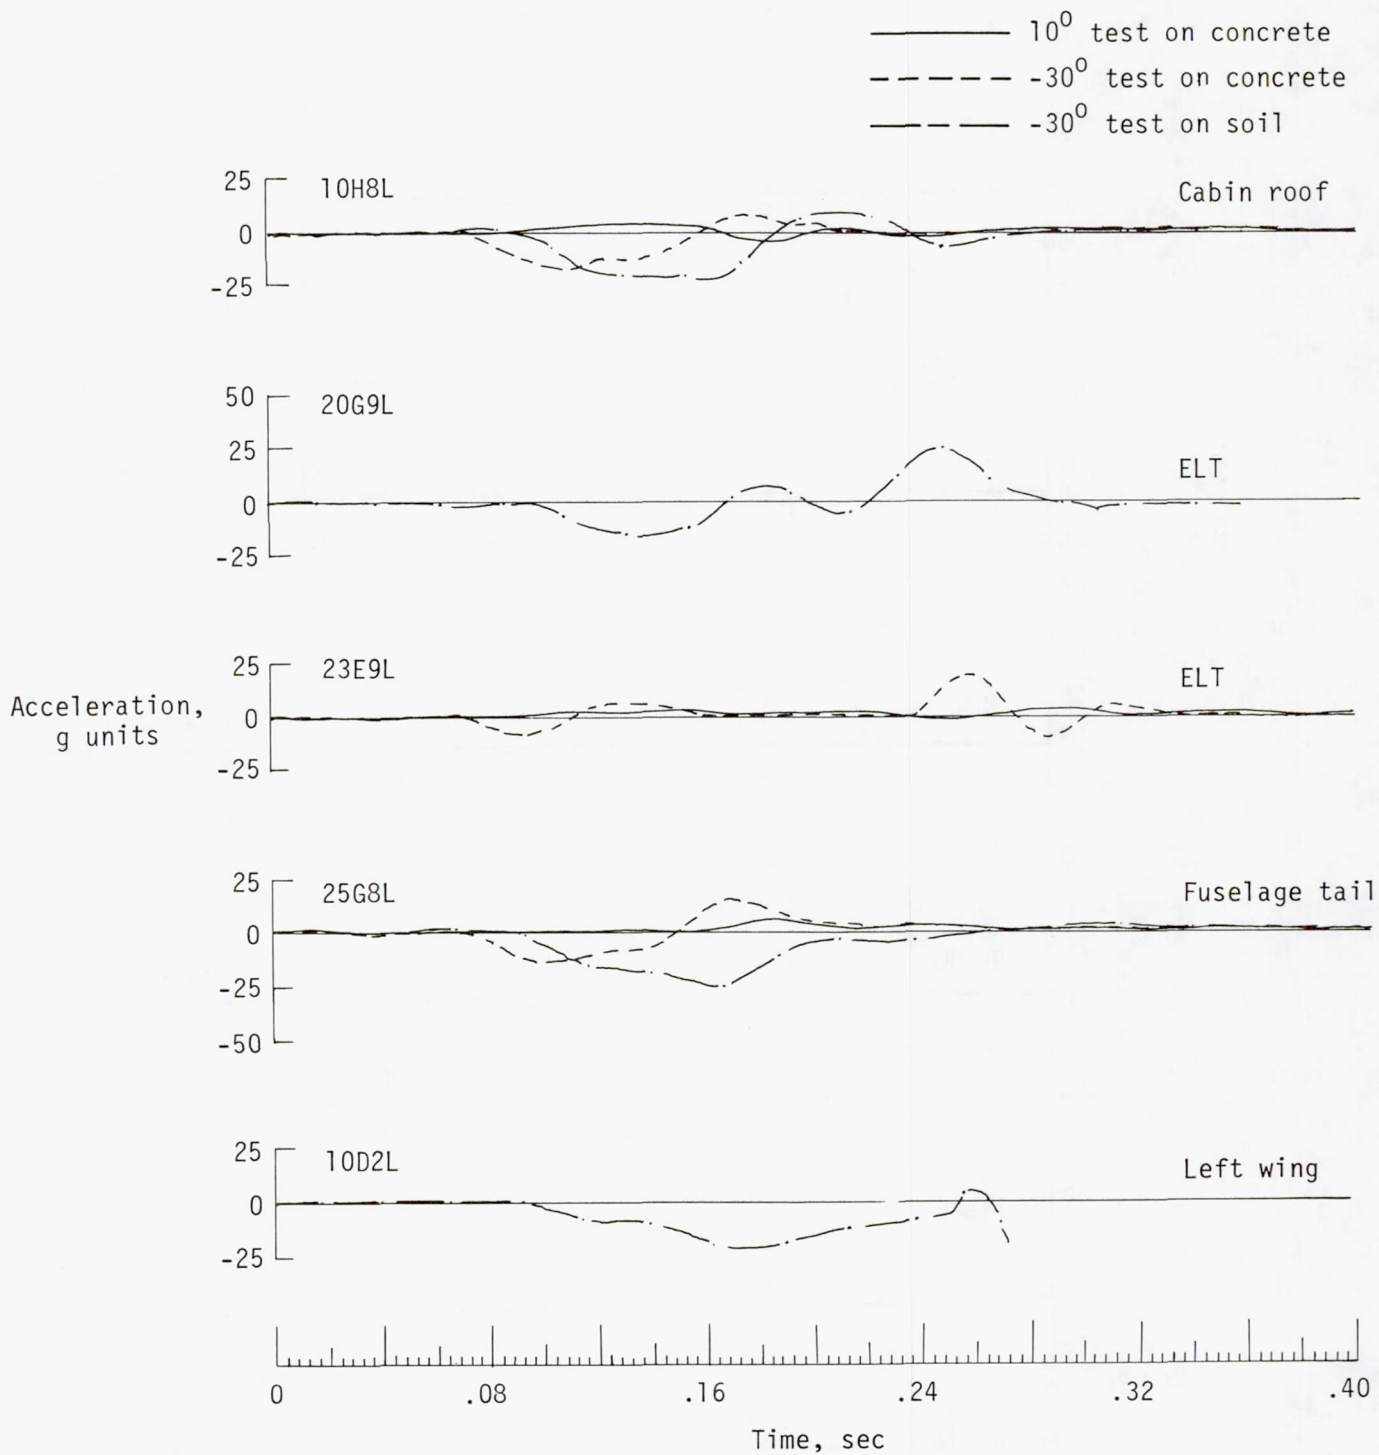
Figure 21.- Longitudinal accelerations on cabin roof, fuselage tail, left wing, and at ELT location.

Cabin roof, fuselage tail, and left wing.- Longitudinal accelerations on the cabin roof, fuselage tail, and left wing are presented in figure 21. The highest accelerations were recorded for the -30° test on soil, and the lowest were for the 10° test on concrete. On the cabin roof, peak accelerations were small and varied from 5g to -5g for the 10° test on concrete, 8g to -17g for the -30° test on concrete, and 9g to -22g for the -30° test on soil. Accelerations at the Emergency Locator Transducer (ELT) location were -3g, -8g, and -14g for the 10° test on concrete, the -30° test on concrete, and the -30° test on soil, respectively; whereas on the tail at the fuselage top, the peak accelerations were -5g, -15g, and -25g,

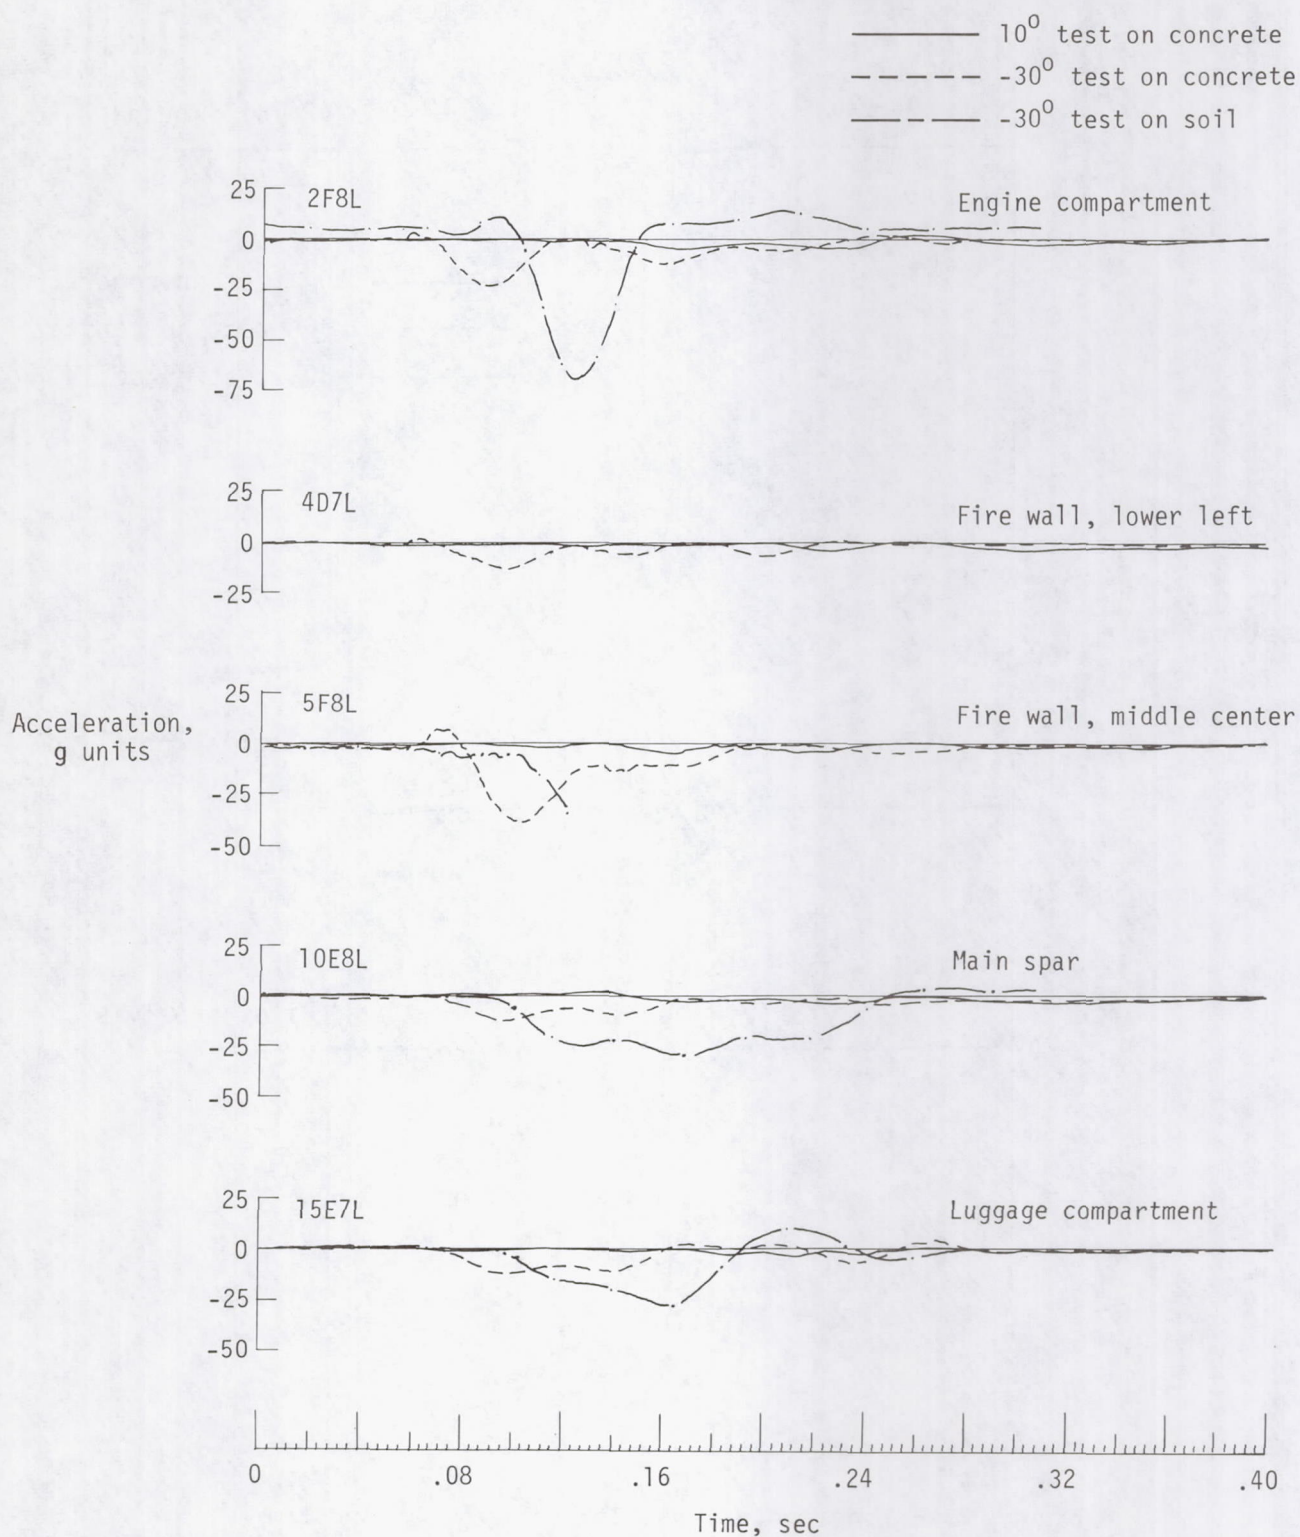
Figure 22.- Longitudinal accelerations in engine compartment and fire wall, main spar, and luggage compartment.

Engine compartment, main spar, and luggage compartment.- Longitudinal accelerations in the engine compartment, main spar, and luggage compartment are presented in figure 22. Peak longitudinal accelerations recorded on the engine were -5g for the 10° test on concrete, -24g for the -30° test on concrete, and -77g for the -30° test on soil. For the 10° test on concrete, peak accelerations were -2g on the lower left portion of the fire wall and -3g on the middle portion. For the -30° test on concrete, the peak accelerations were -14g and -38g, respectively. Fire-wall data were lost for the -30° test on soil. In the main spar, the longitudinal peak accelerations were -4g for the 10° test on concrete, -13g for the -30° test on concrete, and -30g for the -30° test on soil. In the luggage compartment, the peak accelerations were -5g, -12g, and -27g, respectively. In general, the acceleration magnitudes at these locations were highest for the test on soil and lowest for the 10° test on concrete.

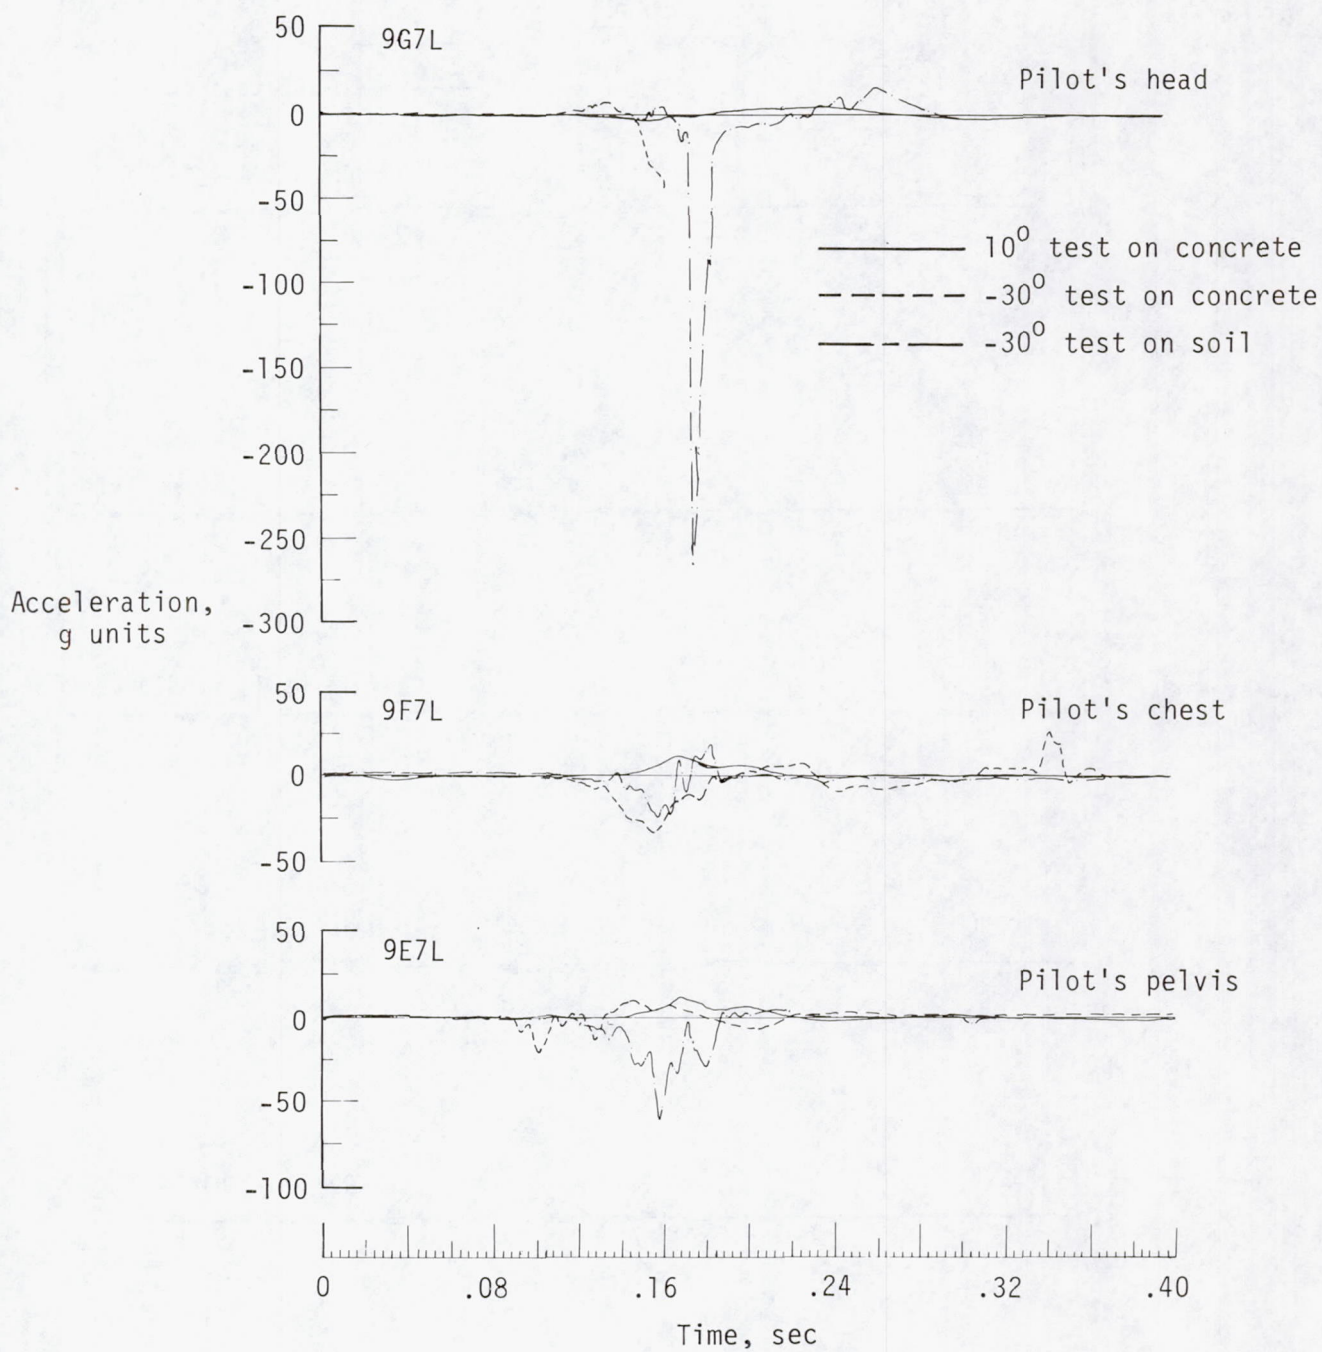
Figure 23.- Longitudinal accelerations in pilot dummy.

Pilot dummy.- Longitudinal accelerations in the pilot's head, chest, and pelvis are presented in figure 23. In the pilot's head, a peak acceleration of -5g was obtained in the 10° test on concrete. In the -30° test on concrete, a partial acceleration trace with a value of -40g was obtained before the data were lost. An acceleration of -240g occurred in the -30° test on soil because high-speed motion-pictures for this test showed the pilot's head striking the instrument panel. A high-acceleration spike of short duration is indicative of such an impact. In the pilot's chest, the longitudinal peak accelerations were -12g in the 10° test on concrete, -33g in the -30° test on concrete, and -24g in the -30° test on soil. In the pilot's pelvis, the longitudinal peak accelerations were -6g in the 10° test on concrete, -23g in the -30° test on concrete, and -60g in the -30° test on soil. No longitudinal accelerations were measured in the copilot dummy.

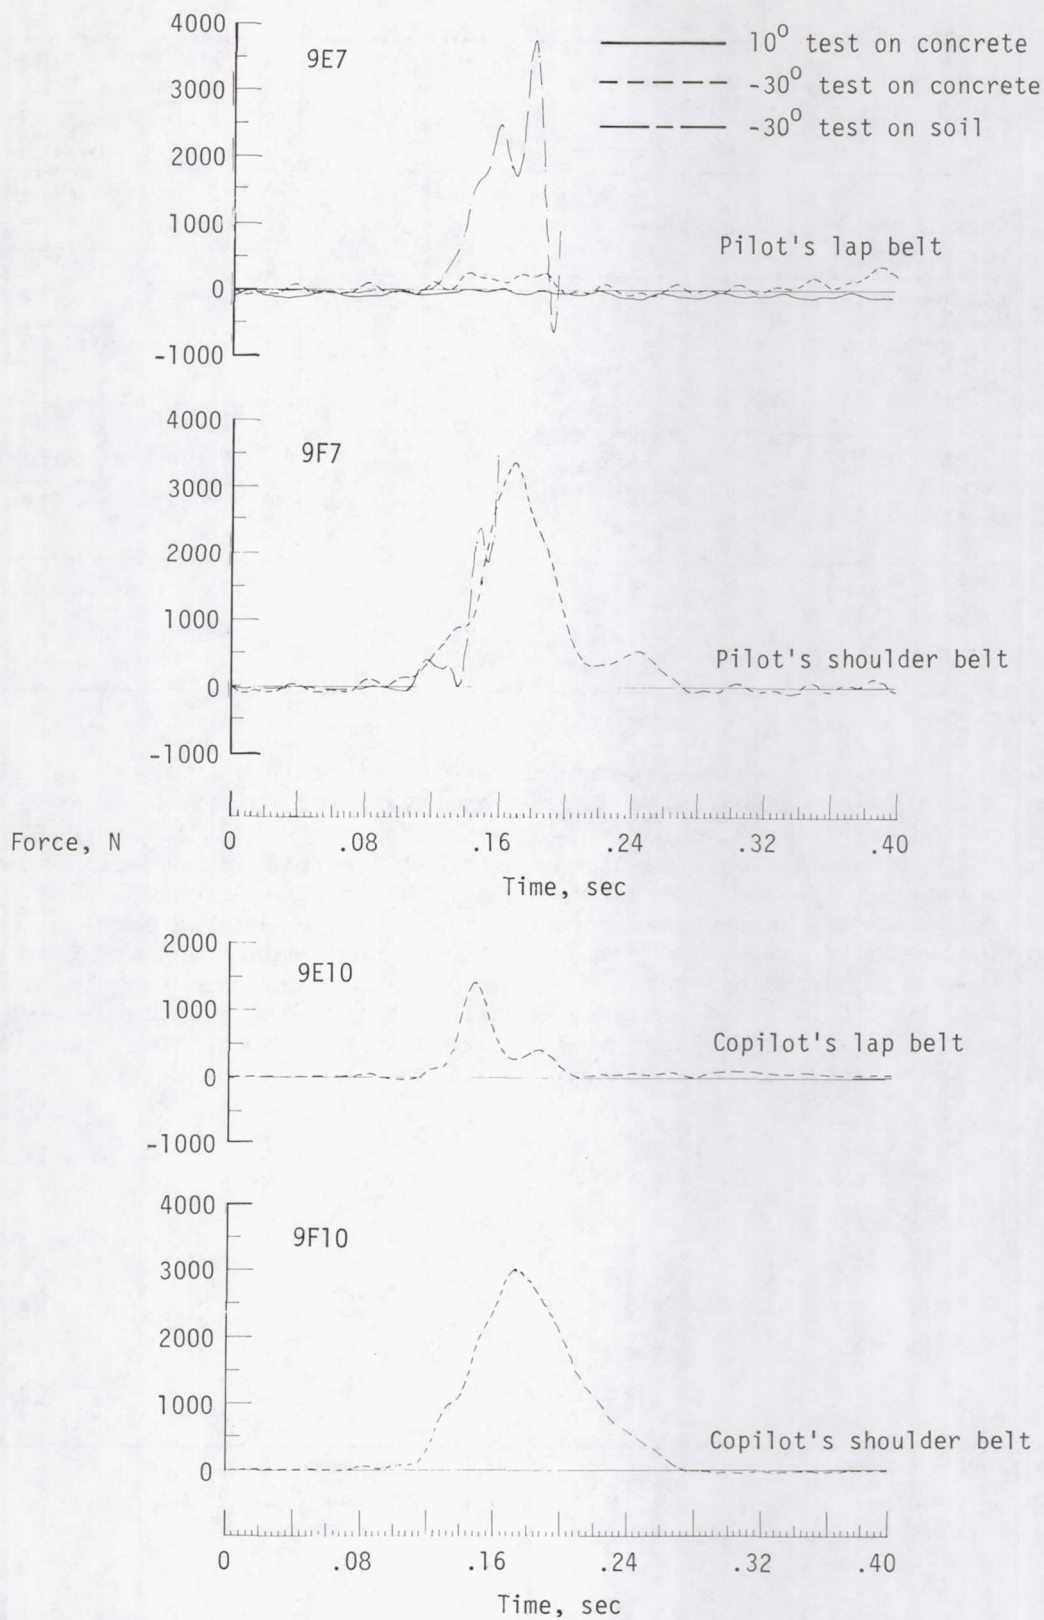
Figure 24.- Tension in restraint-harness system.

Tension for the lap belt and shoulder harness in the pilot and copilot dummies are shown in figure 24. Loads in the pilot's lap belt were negligible for the 10° test on concrete, 200 N for the -30° test on concrete, and 3700 N for the -30° test on soil. In the pilot's shoulder harness, the loads were negligible for the 10° test on concrete, 3400 N for the -30° test on concrete, and 3800 N for the -30° test on soil. In the copilot's lap belt and shoulder harness, the loads were negligible for the 10° test on concrete; but they were 1400 N and 3000 N, respectively, for the -30° test on concrete. For the -30° test on soil, no measurements were made on the copilot's lap belt and shoulder harness. Attempts to correlate restraint loads with accelerations of the dummies and seats were not made because loads are measured in directions other than the accelerations, seat/occupant interactions may be different for different seats under the same apparent loadings, and dummies striking the airplane structure alter drastically the various responses of dummies and seats.
